ROAMING WOODS LAKE DAM

PHASE I INSPECTION REPORT NATIONAL DAM INSPECTION PROGRAM

JULY 1978

ROAMING WOODS LAKE DAM
WAYNE COUNTY, PENNSYLVANIA
NATIONAL I.D. NO. PA 00166

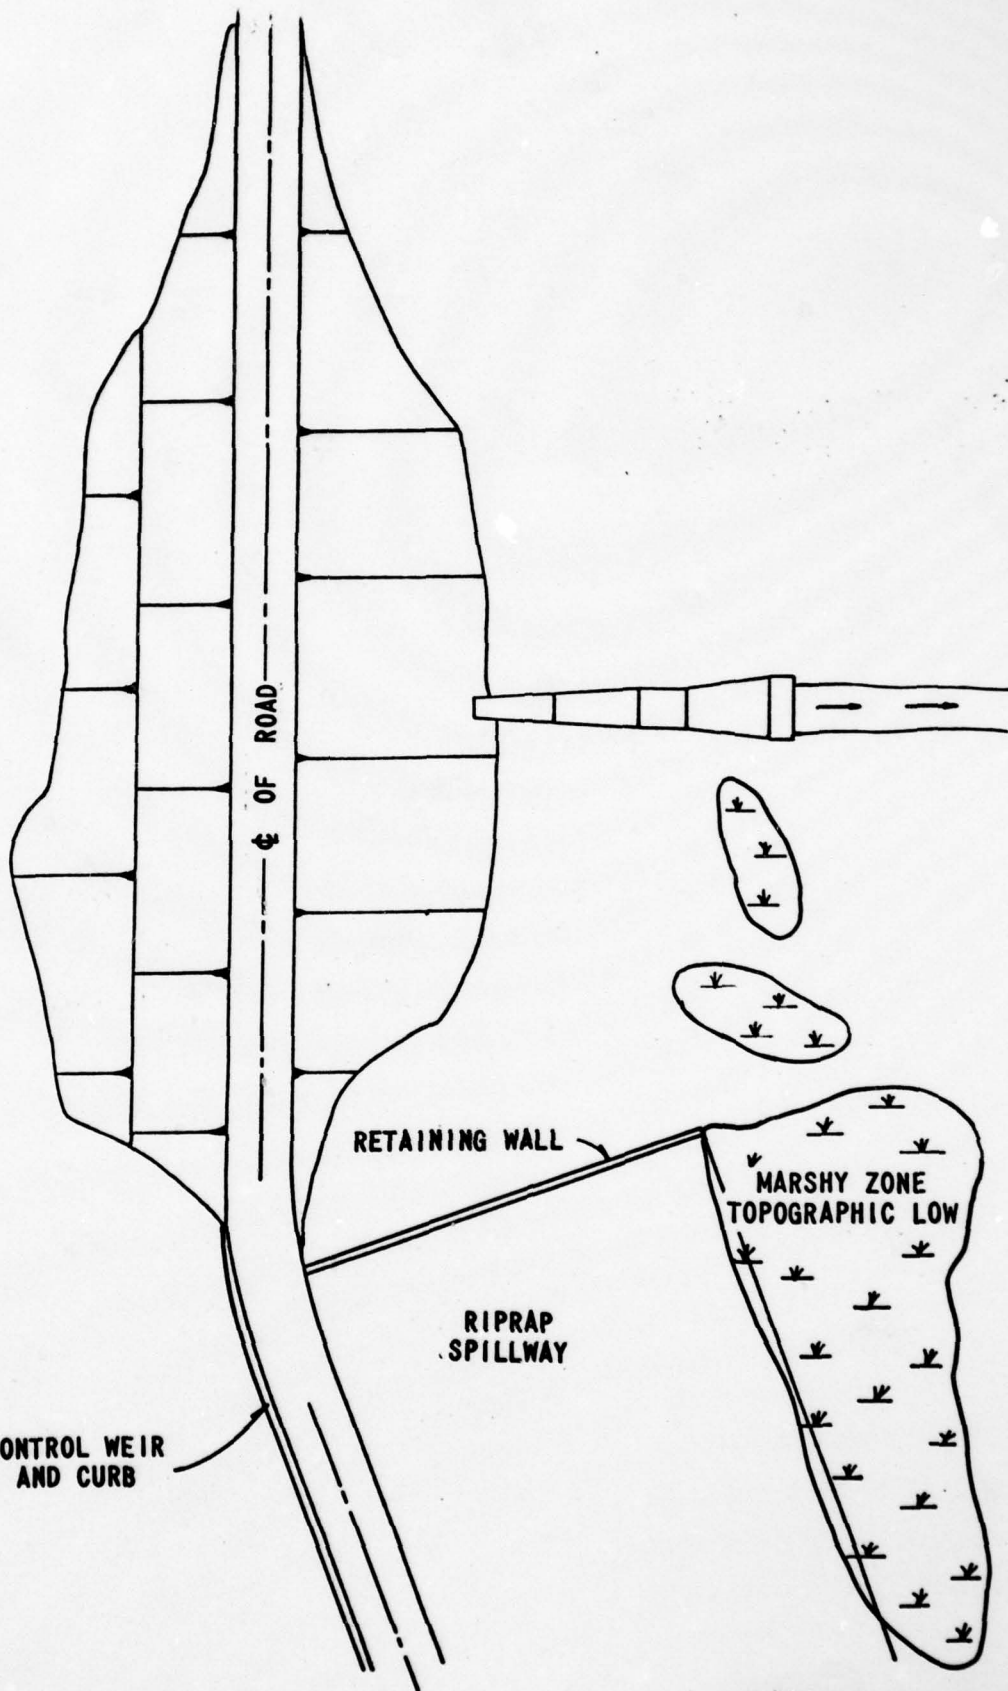
SHEET 5a OF 11

The downstream toe of the emergency spillway has standing water and cattails. Two isolated wet zones between the spillway toe and principal discharge system were observed. Flow was not observed in these areas. See sheet 5 a.

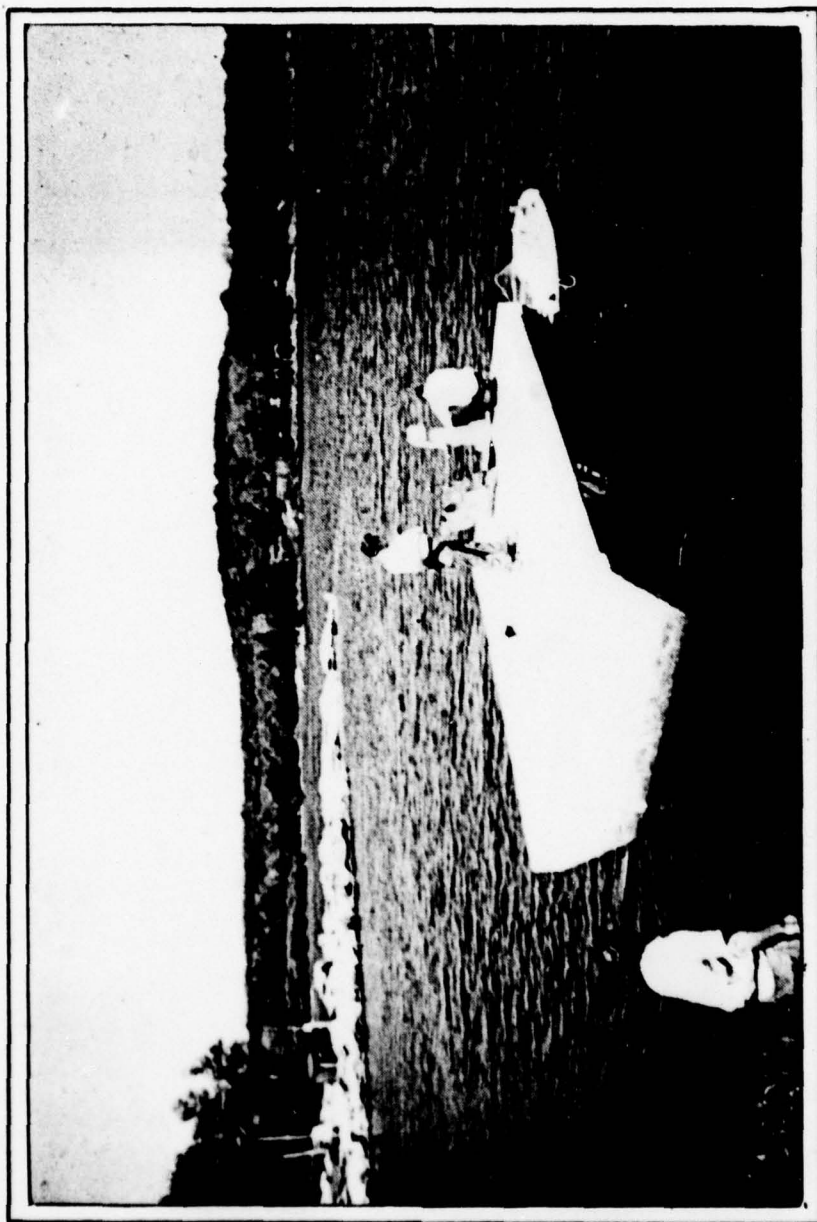
PHOTOGRAPH NO. 1

VIEW OF PRINCIPAL INTAKE STRUCTURE.
NOTE WEIR AND POND DRAIN VALVE.

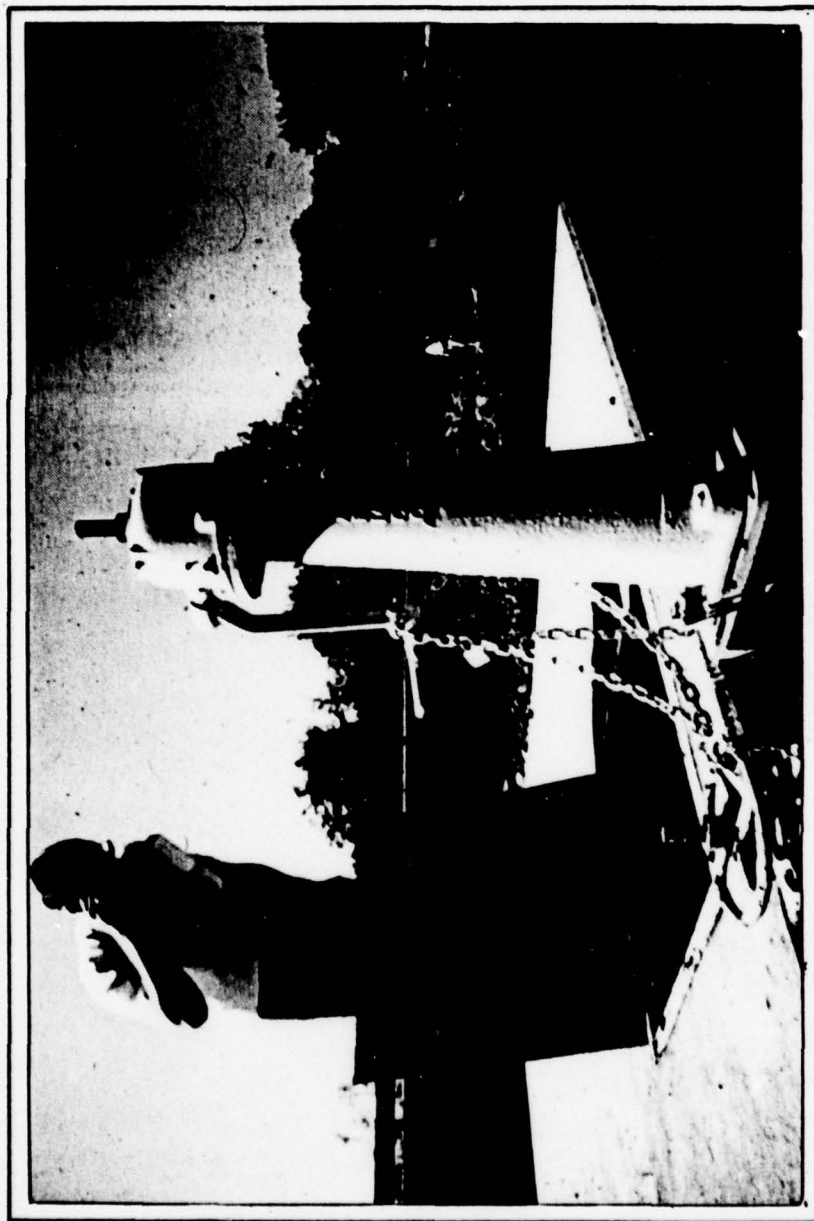
PHOTOGRAPH NO. 2

Data located in DER files indicates that the eight inch pipe was designated for use to maintain minimum flow. However, this valve was closed. During the inspection, water was found to be flowing through leaks in the pond drain valve. This flow was estimated to meet or exceed minimum flow requirements. During the winter, the reservoir is lowered three to five feet so that the water level is below the dock facilities. Since this structure was built, the emergency spillway has never experienced flow. There are no other known operational requirements for this dam and reservoir.

VIEW OF POND DRAIN VALVE.

It is believed that current operating procedures are a realistic means of operating the relatively simple control facilities of Roaming Woods Lake Dam. Although the eight-inch valve is not being used to maintain minimum flow, normal leakage of the pond drain gate appears to be satisfying this flow. During the lifetime of this facility sediment may eventually block the pond drain system. If minimum flow requirements are to be continued through the pond drain, it is recommended that 1) the gate be exercised at least yearly to maintain an open channel to the drain and 2) the valve be calibrated to assure that minimum flow is maintained.

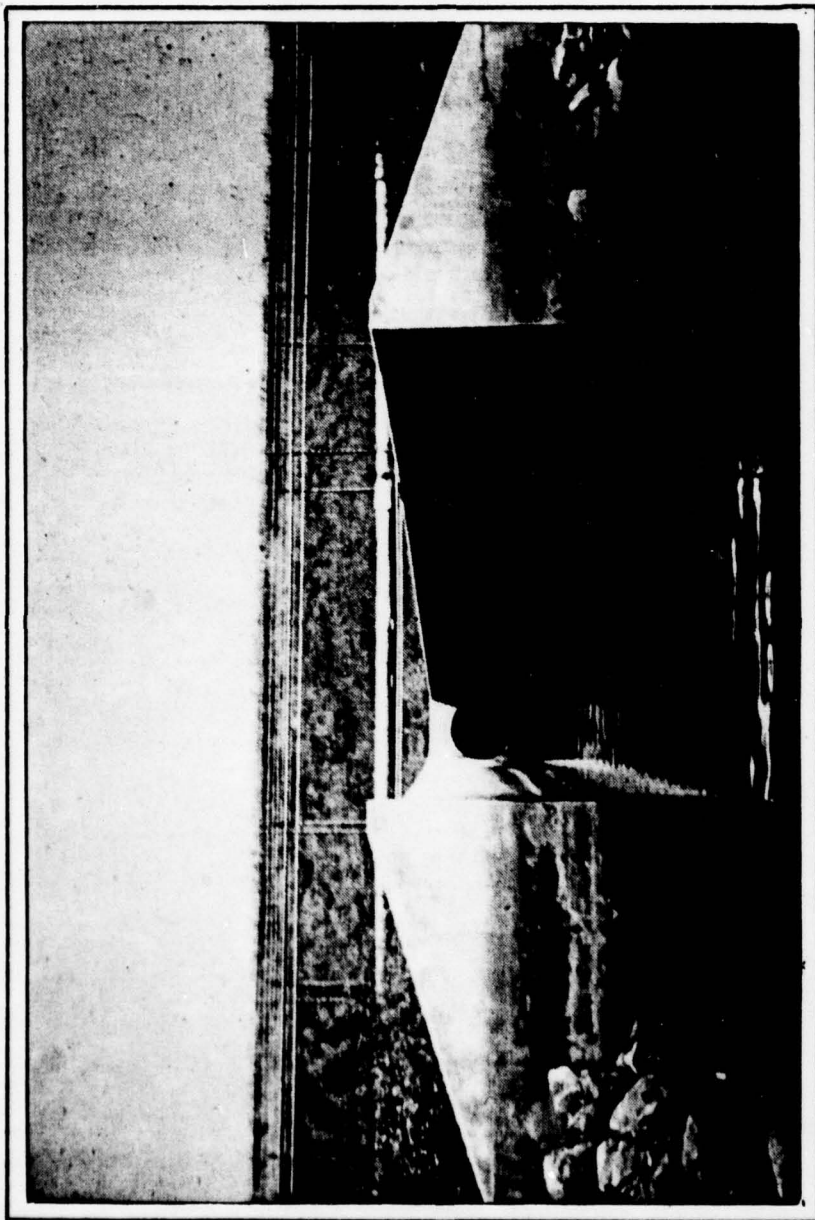
PHOTOGRAPH NO. 4

VIEW LOOKING UPSTREAM INTO STILLING
BASIN. NOTE HIGH WATER MARKS ON
THE WING WALLS.

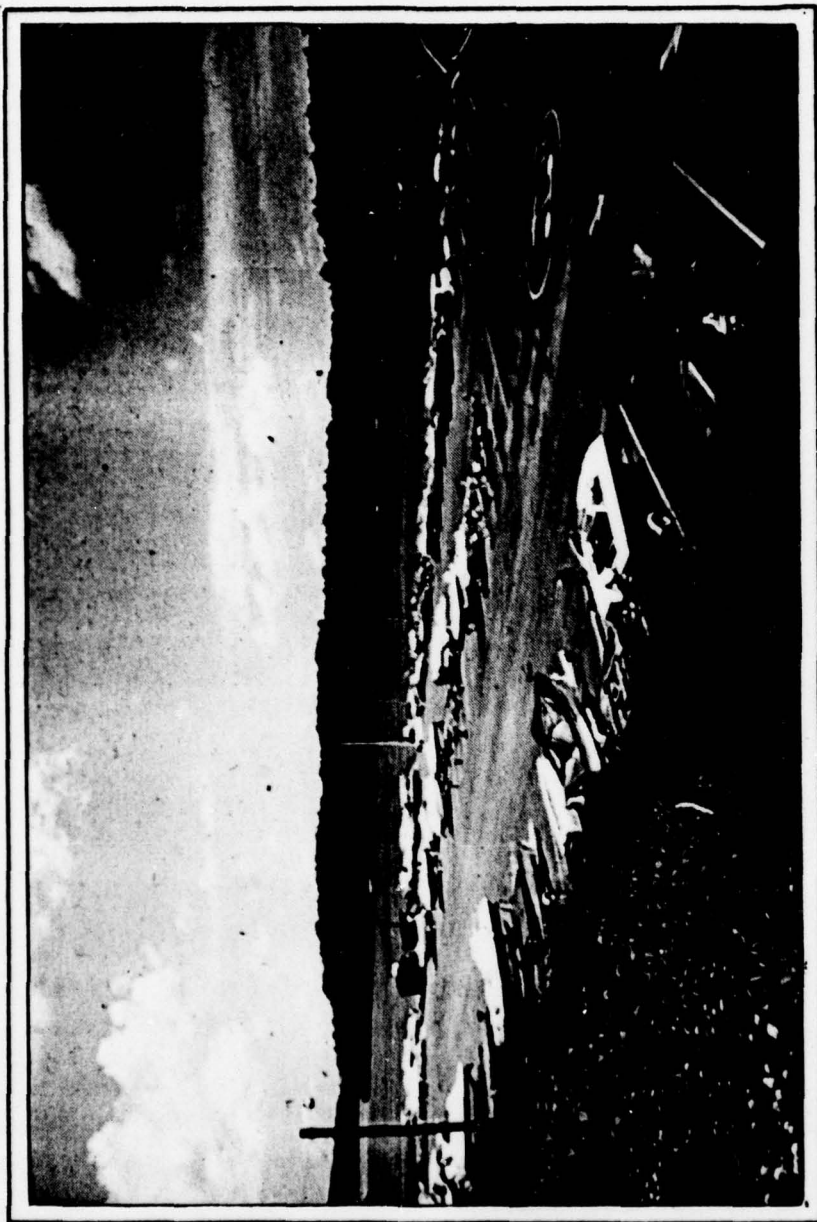
PHOTOGRAPH NO. 5

c. Visual Observations. Detailed visual observations concerning the reservoir, spillways, and downstream channel are contained in Appendix B. It should be noted that the approach channel to the emergency spillway is paved and is being used as a marina, parking lot and storage area for canoes, boats, and boat trailers. Also located in this area are two sheds used by the marina personnel. The lakeward sides of the marina are lined with large decorative boulders with tops that are approximately at or below the elevation of the emergency spillway. It is considered likely that flow through the emergency spillway will be slightly, but insignificantly, reduced because

VIEW OF EMERGENCY APPROACH CHANNEL.
NOTE BOATS AND OTHER OBSTRUCTIONS
IN PARKING AREA.

1. In view of the obstructions in the approach channel, it is recommended that the emergency spillway be re-assessed. It is not recommended that the channel be used to store boats, trailers or serve as a parking lot.
2. The riprap discontinuity along the water's edge should be re-evaluated by a qualified engineer and rehabilitated in accordance with the engineer's recommendations.
3. It is recommended that the Owner contact a professional engineer and obtain a procedure for operating the two gates in the intake riser. Specifically, clarification should be obtained on when and how to use the eight-inch valve and how to operate the pond drain valve to satisfy minimum flow requirements.

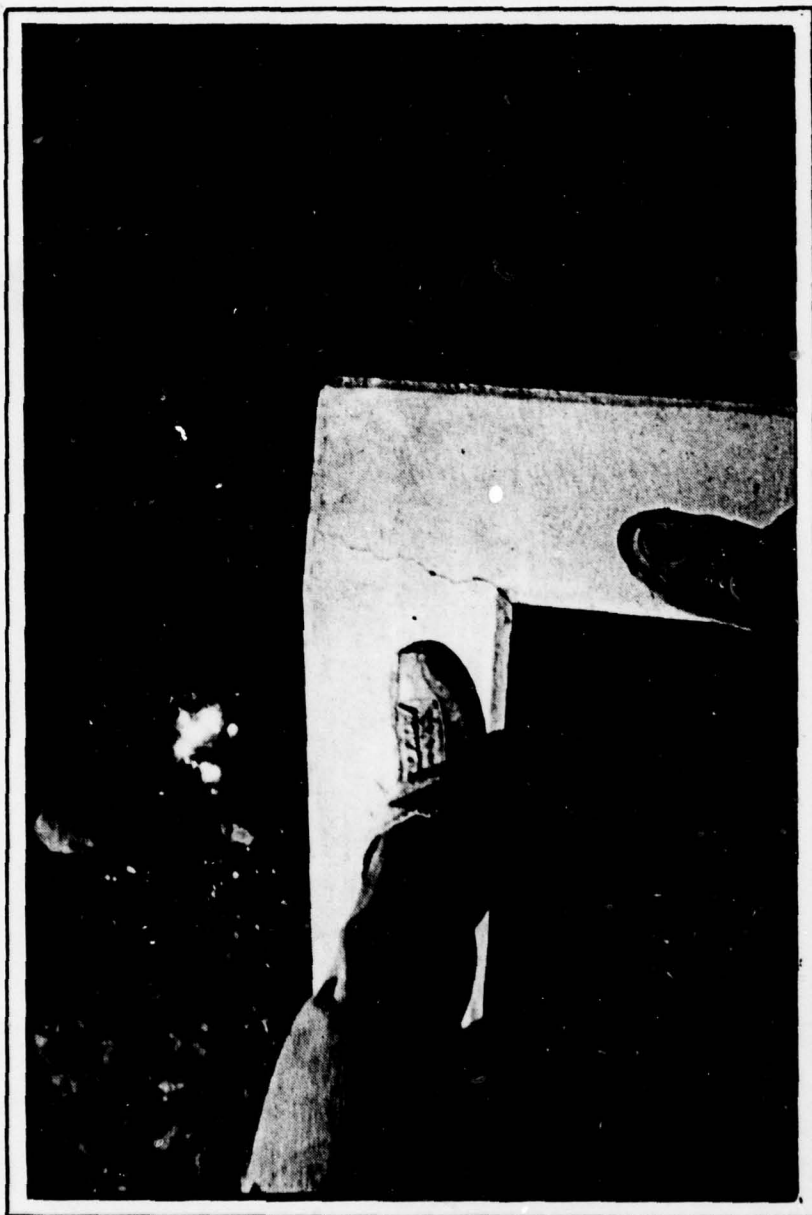
PHOTOGRAPH NO. 10

walls. One minor tension crack was observed along the left wing wall. This crack is described in Appendix B, Sheet 6 of 11 and shown on Photograph No. 10.

MINOR CRACKING OF LEFT WING WALL.

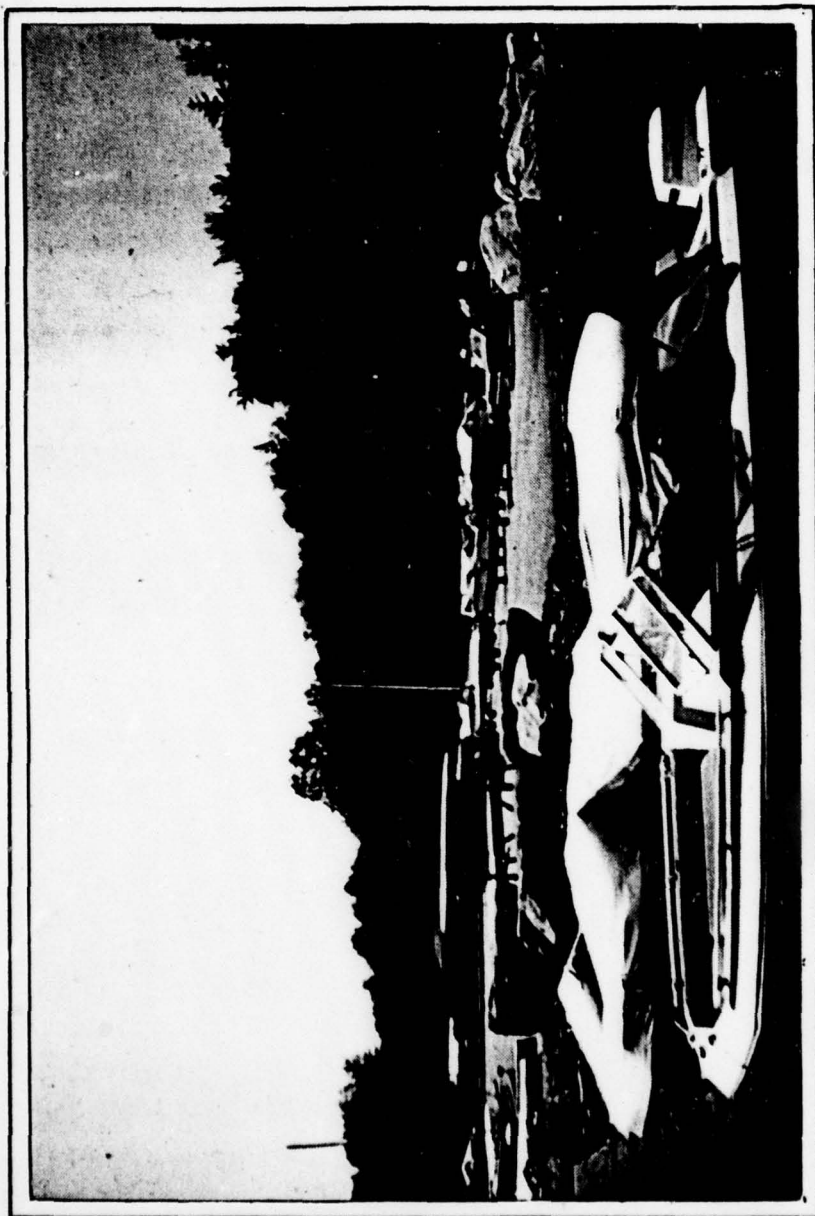
PHOTOGRAPH NO. 11

VIEW OF OBSTRUCTIONS IN THE EMER-
GENCY SPILLWAY.
